Manhole Inspection Summary

Manhole # S31KK1027MH

Location Address: **12 WHITFIELD RD**

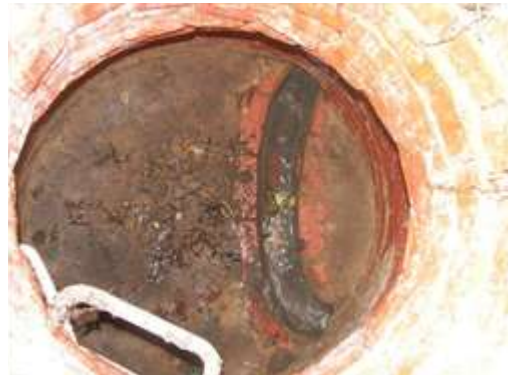
Top View

Evidence of surcharge - Bench debris.

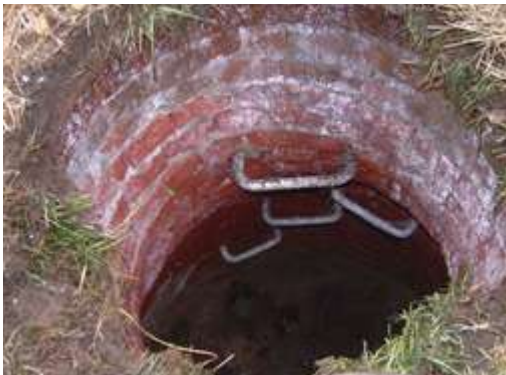
Defect

Frame Offset: **0** (in.) Condition: ☐ Sound ☐ Cracked ☒ **Leaks**

Condition: ☐ Sound ☐ Cracked ☐ Root Intrusion ☐ Loose Brick ☒ **Deteriorated**

Infiltration: ☐ None ☒ **Joint** ☐ Cracks ☐ Mortar ☐ Roots ☒ **Wall**

Frame leaks. Adjustment deterioration and infiltration. Corbel and Barrel infiltration.

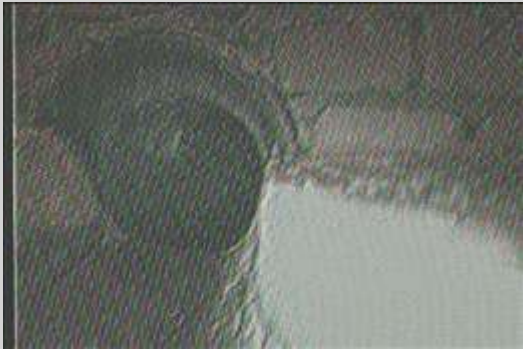
8 in. Circular Gravity Sewer Pipe Out @ 12 O'Clock

Infiltration: **None** Pipe Seal Cond: **Cracked**

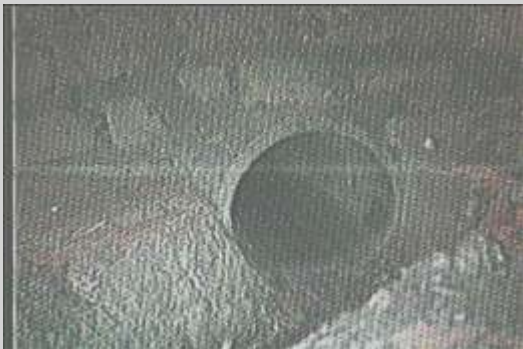
6 in. Circular Gravity Sewer Pipe In @ 4 O'Clock

Infiltration: **None** Pipe Seal Cond: **Unknown**
